2024

Statewide Airfield Pavement Management Program

AIRFIELD PAVEMENT EVALUATION REPORT

CEW - Bob Sikes Airport | *District 3*

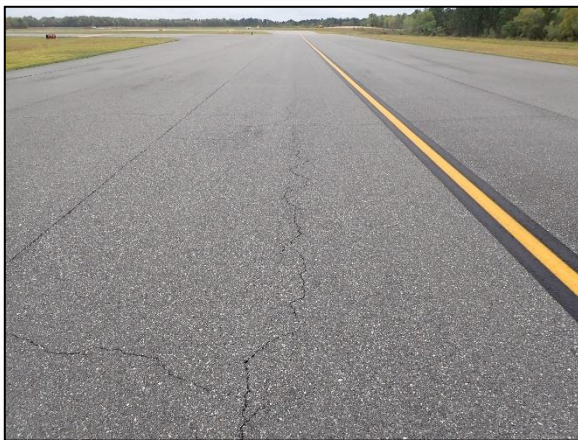
TW A:110

TW A consists of 6 flexible pavement sections, totaling 673,717 sf. The last major construction date for the branch was 2012, resulting in an area-weighted average age at inspection of 11 years old. Overall, TW A is in Fair condition with an area-weighted average PCI of 70.

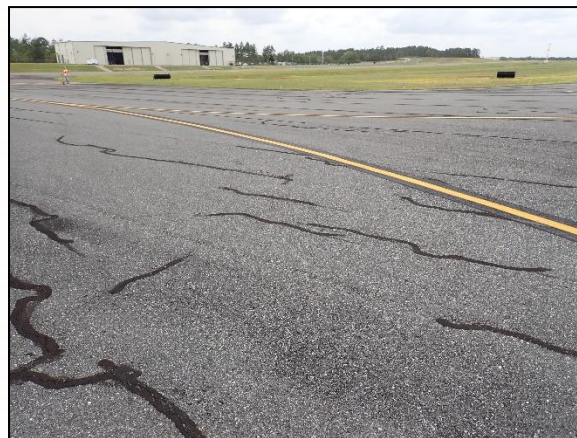
TW A4:130

TW A4 consists of 2 flexible pavement sections, totaling 79,280 sf. The last major construction date for the branch was 2012, resulting in an area-weighted average age at inspection of 11 years old. Overall, TW A4 is in Fair condition with an area-weighted average PCI of 64.

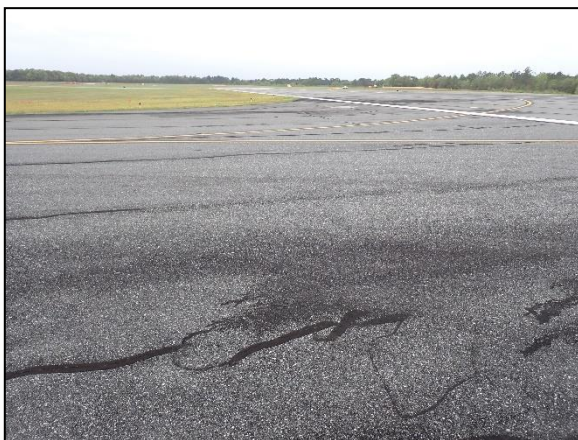
TW E:505

TW E consists of 3 flexible pavement sections, totaling 108,578 sf. The last major construction dates range from 1999 to 2008, resulting in an area-weighted average age at inspection of 24 years old. Overall, TW E is in Fair condition with an area-weighted average PCI of 69.

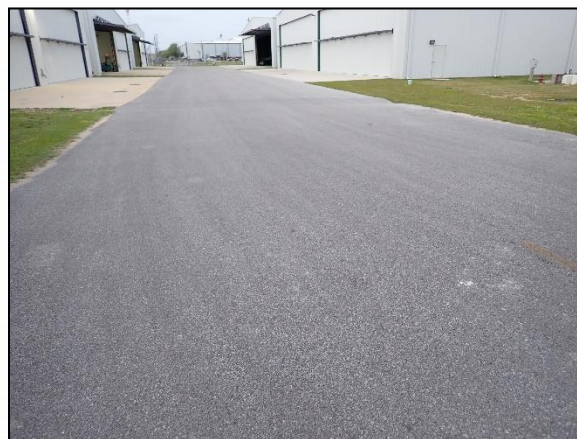
TL K: 3405

TL K consists of 1 flexible pavement section, totaling 25,450 sf. The last major construction date for the branch was 2008, resulting in an area-weighted average age at inspection of 16 years old. Overall, TL K is in Fair condition with an area-weighted average PCI of 66.

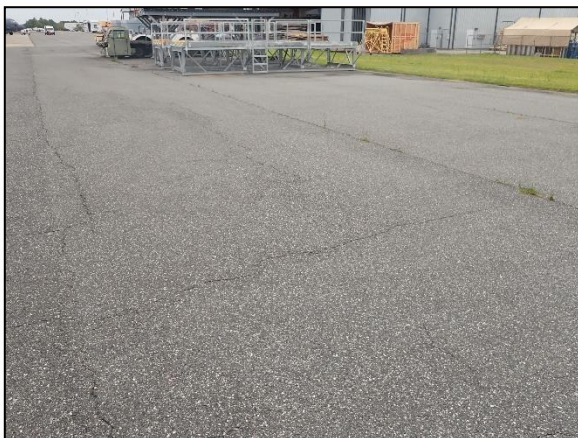
AP N:4345

AP N consists of 3 flexible and 1 rigid pavement sections, totaling 261,866 sf. The last major construction date for the branch was 2012, resulting in an area-weighted average age at inspection of 11 years old. Overall, AP N is in Fair condition with an area-weighted average PCI of 59.

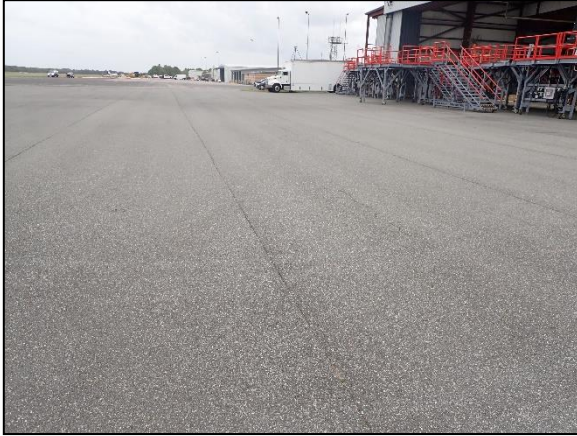
AP S:4120

AP S consists of 3 flexible and 1 rigid pavement sections, totaling 515,494 sf. The last major construction dates range from 2012 to 2024, resulting in an area-weighted average age at inspection of 4 years old. Overall, AP S is in Good condition with an area-weighted average PCI of 91.
