2024

Statewide Airfield Pavement Management Program

AIRFIELD PAVEMENT EVALUATION REPORT

CEW - Bob Sikes Airport | *District 3*

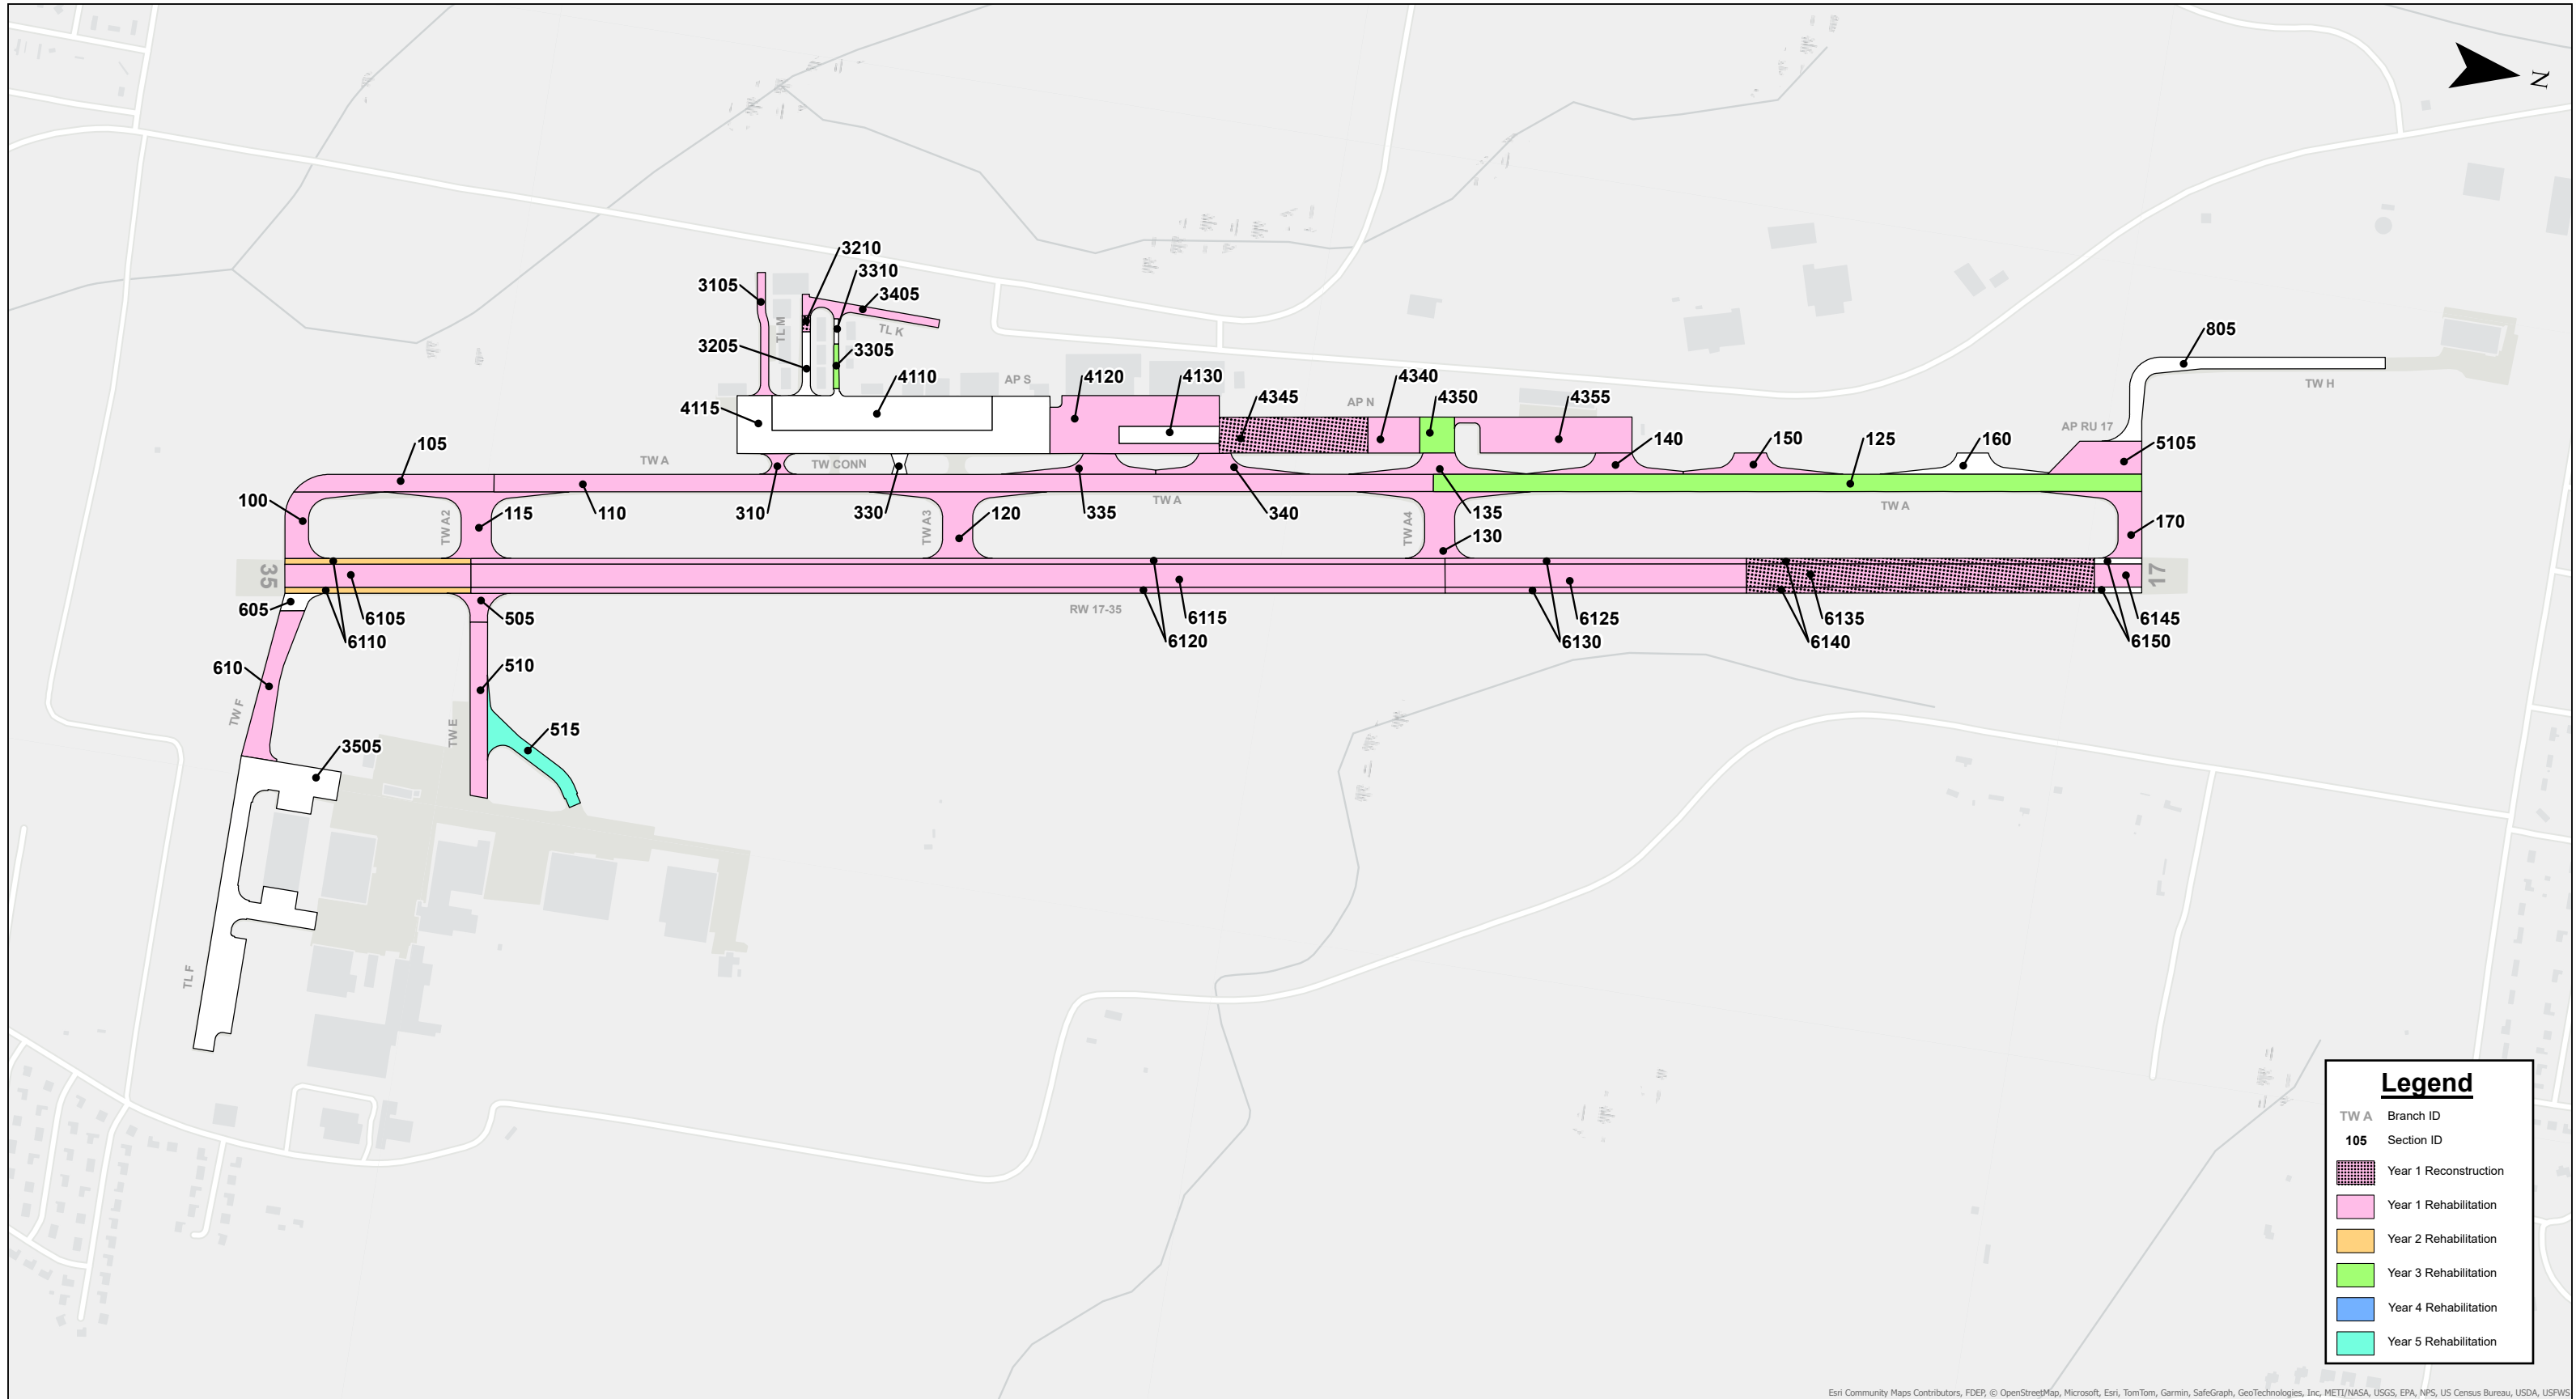
5-Year Major Rehabilitation Needs

The **Major Rehabilitation Exhibit** depicts which sections will need major rehabilitation within the next 5 years. **Appendix B** provides a section-level detailed summary of these needs in addition to the cost of various rehabilitation options should a different pavement rehabilitation type be desired.

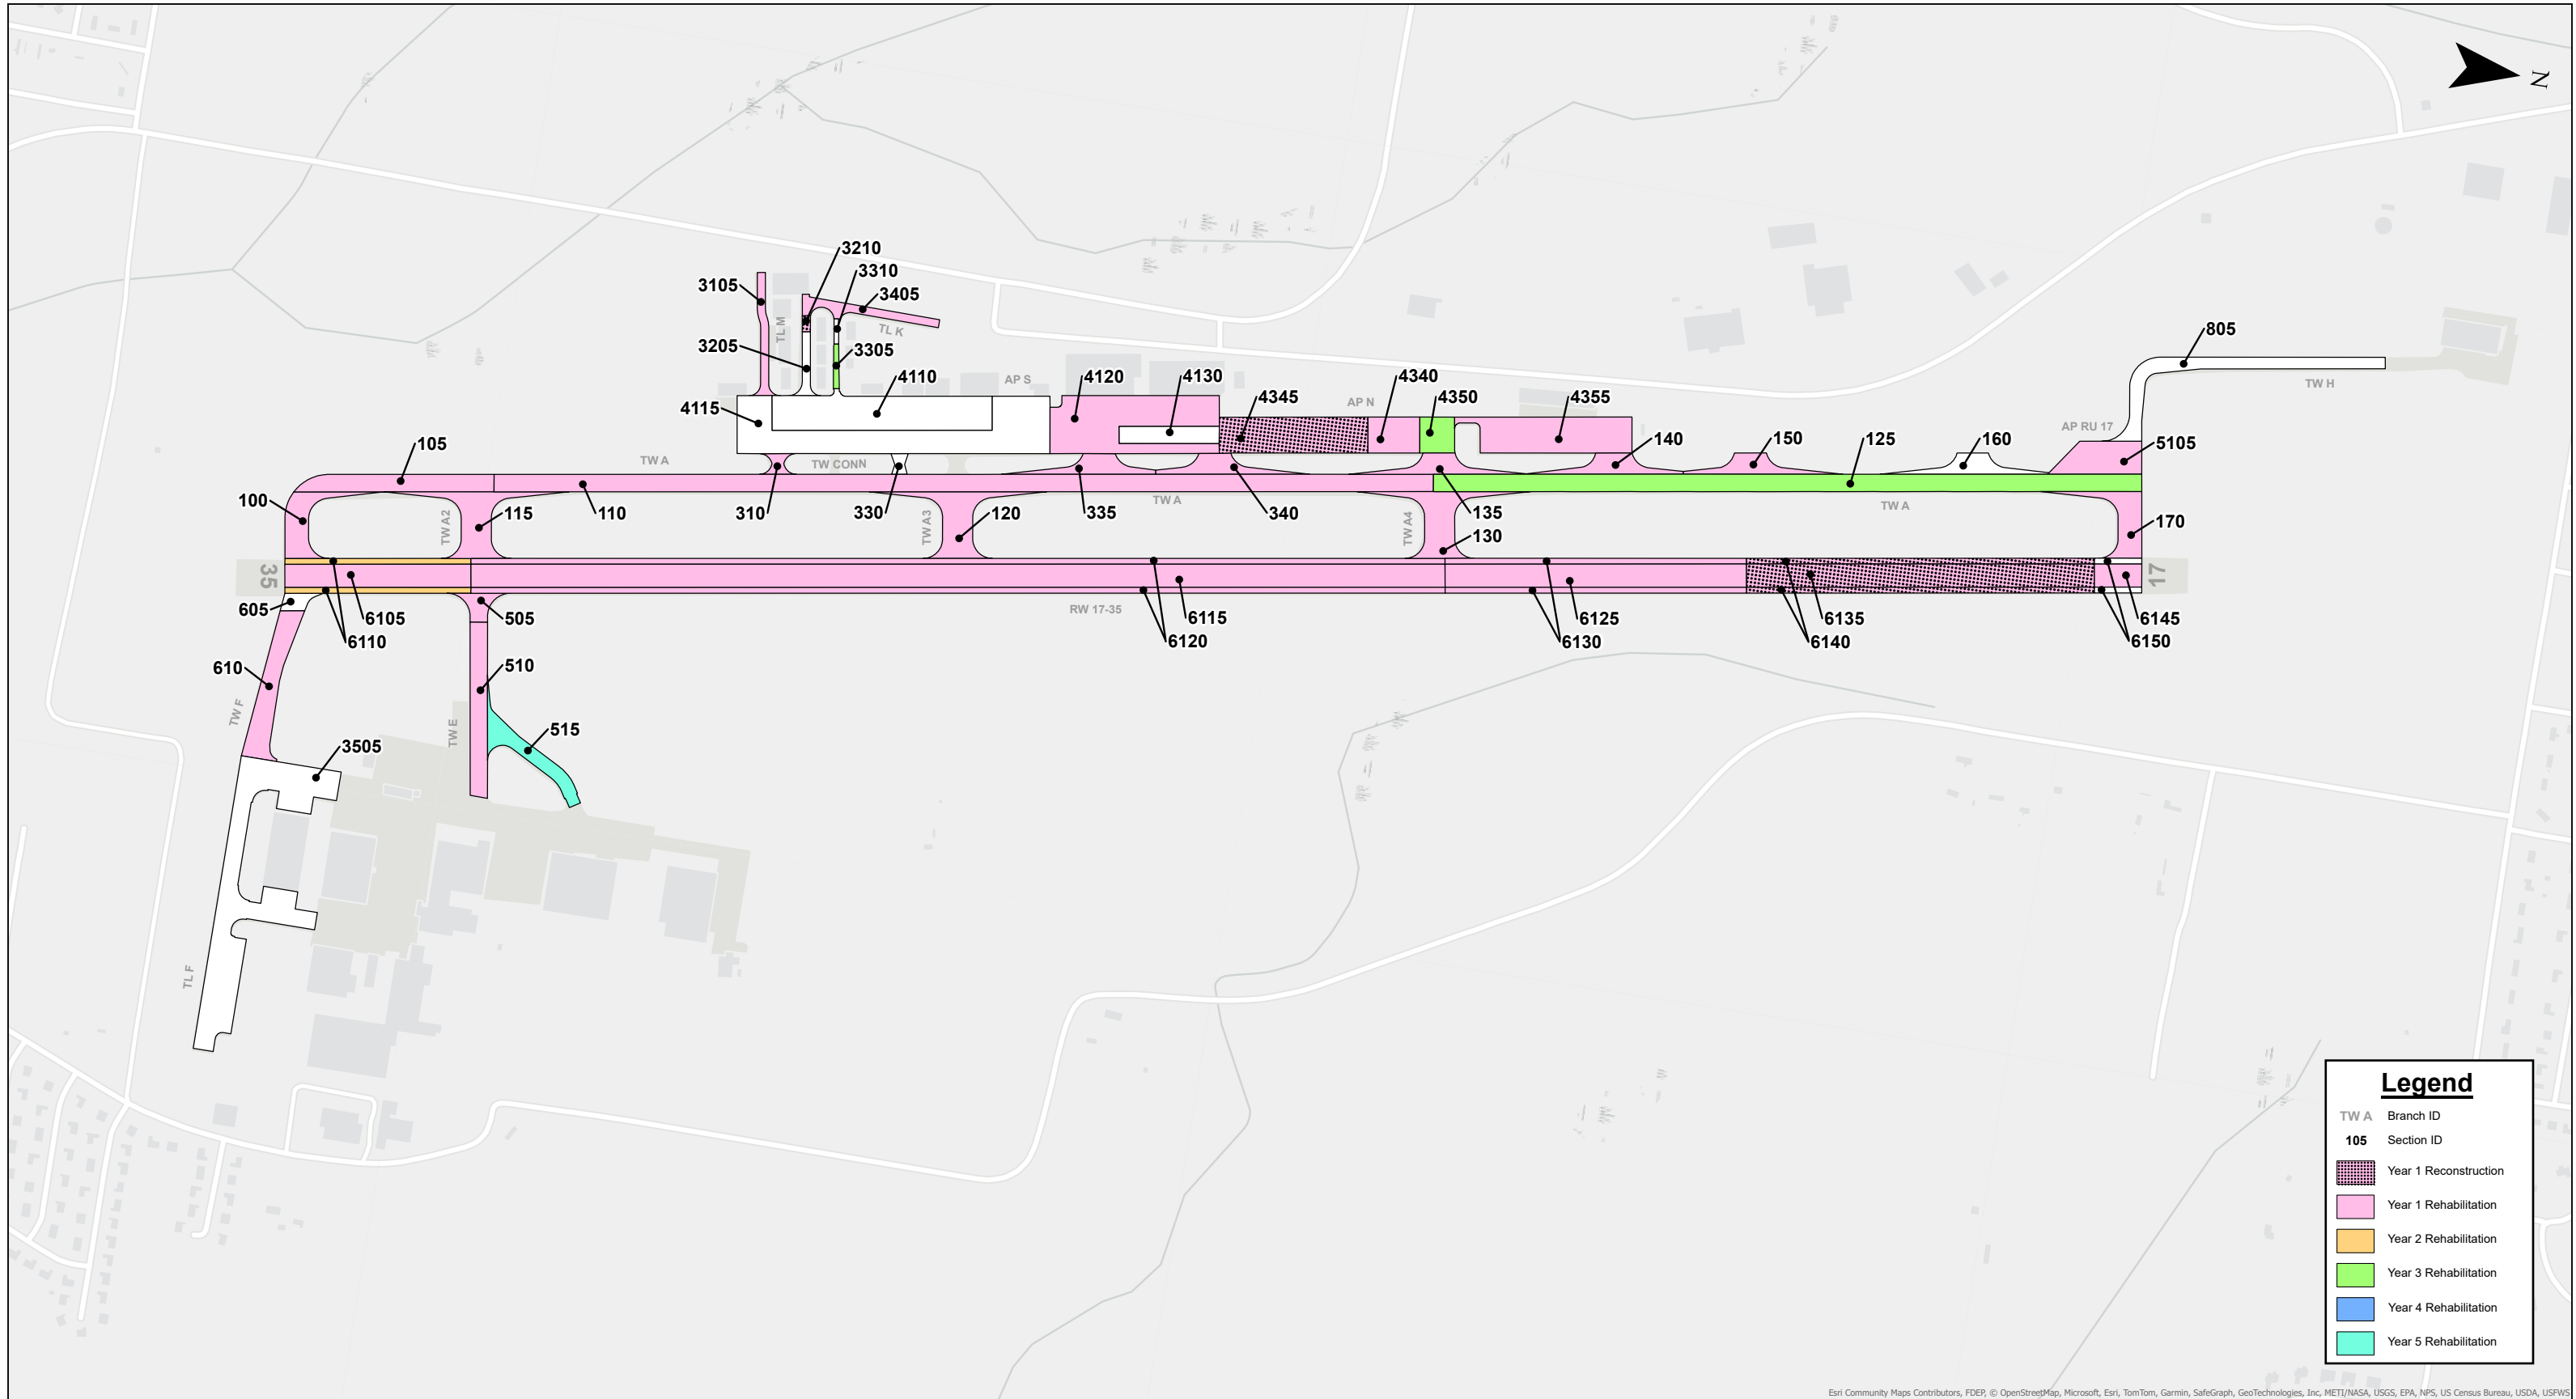
5-Year Major Rehabilitation Needs

Year 1	CEW	TL M	3105	AC	19,711	69	AC Rehabilitation	\$ 252,000	\$ 252,000	\$ 602,000	-	-	-	-
Year 1	CEW	AP N	4340	AAC	34,591	57	AC Rehabilitation	\$ 442,000	\$ 442,000	\$ 1,056,000	-	-	-	-
Year 1	CEW	AP N	4345	AC	99,461	51	AC Reconstruction	\$ 2,412,000	-	-	\$ 2,412,000	\$ 1,940,000	-	-
Year 1	CEW	AP N	4355	AC	104,552	60	AC Rehabilitation	\$ 1,334,000	\$ 1,334,000	\$ 3,189,000	-	-	-	-
Year 1	CEW	AP RU 17	5105	AAC	47,790	59	AC Rehabilitation	\$ 610,000	\$ 610,000	\$ 1,458,000	-	-	-	-
Year 1	CEW	AP S	4120	AAC	147,645	67	AC Rehabilitation	\$ 1,883,000	\$ 1,883,000	\$ 4,504,000	-	-	-	-
Year 2	CEW	RW 17-35	6110	AAC	40,100	68	AC Rehabilitation	\$ 532,000	\$ 532,000	\$ 1,272,000	-	-	-	-
Year 3	CEW	TW A	125	AAC	229,049	68	AC Rehabilitation	\$ 3,159,000	\$ 3,159,000	\$ 7,557,000	-	-	-	-
Year 3	CEW	TL L	3305	AAC	4,434	68	AC Rehabilitation	\$ 62,000	\$ 62,000	\$ 147,000	-	-	-	-
Year 3	CEW	AP N	4350	PCC	23,262	69	PCC Rehabilitation	\$ 988,000	-	-	-	-	\$ 988,000	-

Year 5	CEW	TW E	515	AAC	38,422	69	AC Rehabilitation	\$ 574,000	\$ 574,000	\$ 1,371,000	-	-	-	-
